PEMBINA PIPELINE USES e9 TREATMENTS' NANOTECHNOLOGY-BASED SURFACE TREATMENT

PEMBINA PIPELINE REDUCES DOWNTIME AND RESOURCE DEMAND

Case Study

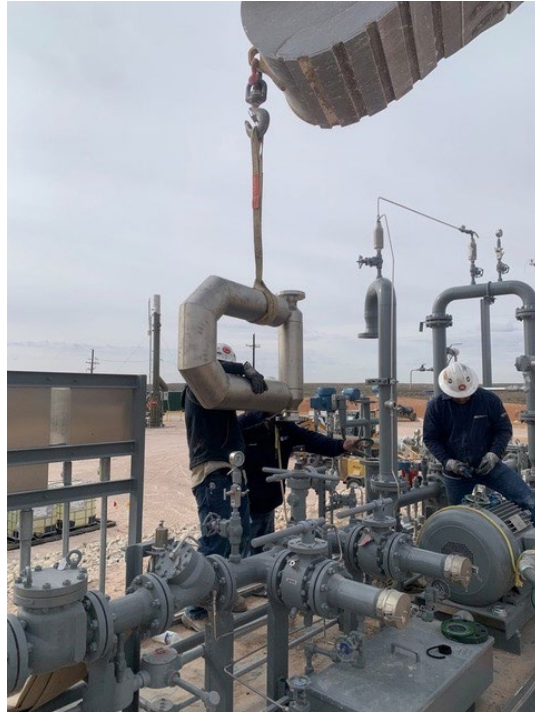
Figure 2. Coriolis being removed from a pipeline.

With leak detection tolerances set to 0.2%, operations shut in the site to investigate. Technicians identified wax build-up on the meter and the site remained shut-in until technicians could remove, clean and re-install the meter. This cycle occurred 1-3 times per week for over a year.

The pipeline downtime resulted in a significant resource draw for Pembina operations with each occurrence. Each shut-in required two operators to drive 2 hours to the site, then spend 2-3 hours removing the meter, steaming the meter to clean it, and re-installing the meter. Additionally, for every occurrence another operator had to drive to the site to prove the meter after it was returned to service. The downtime also caused potential revenue losses for the producer when monthly nominations weren't achieved due to the outages.
