PIPELINE COMPANY IMPROVES SMALL VOLUME PROVER PERFORMANCE

BY: e9 Treatments, Inc. **Todd Mathias**, President

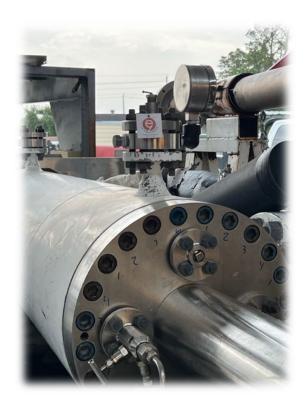
Common in all small volume prover designs are the use of seals. The seals maintain the fluid in each chamber. Inherently, hydrocarbon fluids carry trash or contaminants that often stick to the metal surfaces of the prover. This trash can be paraffin, iron sulfide, scale, or any combination of all of the above. It may also contain everything from plastics to metals lost anywhere along a pipeline. This trash can be hard or sharp, abrasive and nearly impossible to remove from a surface. Trash scratches or scars the seals, causing leaks internally and externally to the prover. Internal leaks cause false meter factors and errors in measurement. External leaks can equipment and site contamination, fires, or even explosions. Trash often permanently damages the shafts and the internal metal sealing surfaces, which results in down time and replacement costs.

e9 Treatments, Inc. offers a nanotechnology based metal surface treatment that, when applied to the prover's metal surfaces, prevents trash/contaminants from sticking or adhering to metal surfaces—primarily the prover shafts and barrel interior. The treatment is proven to slow fouling on sensors, valves, meters, and vessels throughout the oil and gas industry, as well as other industries, saving operators thousands of dollars. e9 treated equipment and flow meters are currently providing precise measurement accuracy and operating efficiency throughout North America and Europe.

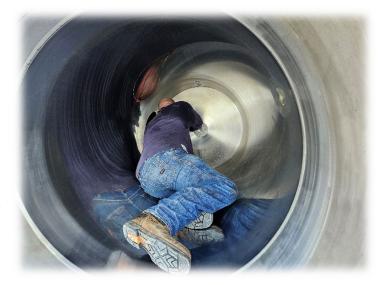
Prior to being treated with e9, this prover had endless seal problems from trash and contaminates building on the shafts and interior of the prover barrel. Every month there were issues.

Build up on the shafts, in particular, was scratching the seals. Seals were developing leaks and leaking internally, impacting the measurement accuracy.

In August of 2023, e9 had the opportunity to apply e9 Pro Premium Metal Treatment to a small volume prover. Treatment was applied on the prover shafts, seals and barrel interior. Material was sprayed on the surface and then wiped in to ensure full coverage. No curing nor drying was needed. The total prover took one man less than 60 minutes to treat.

Over the eight months since treating the prover with e9 Pro Premium Metal Treatment, there have been no issues, no failures, and no leaks. The end user reports savings resulting from no prover downtime, reduced maintenance costs, and no site contamination. Based on these results, the end user has standardized on treating all their small volume provers with e9 Treatments.
