PEMBINA PIPELINE USES e9 TREATMENTS' NANOTECHNOLOGY-BASED SURFACE TREATMENT

## PEMBINA PIPELINE REDUCES DOWNTIME AND RESOURCE DEMAND

### **Case Study**

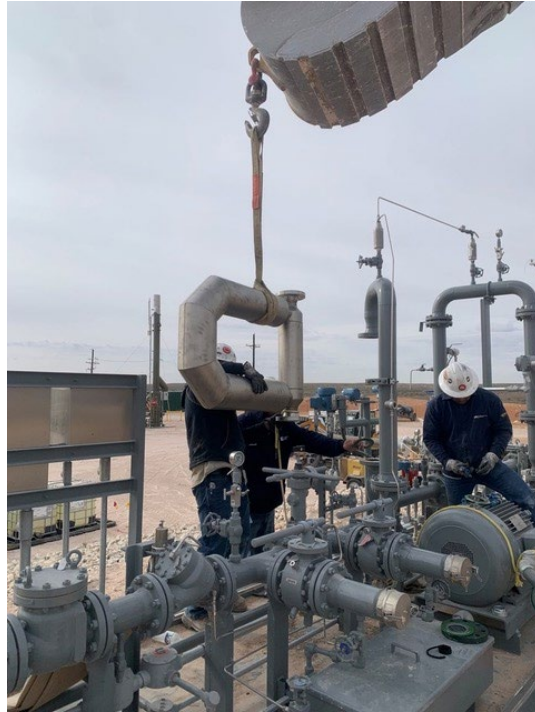
With leak detection tolerances set to 0.2%, operations shut in the site to investigate. Technicians identified wax build-up on the meter and the site remained shut-in until technicians could remove, clean and re-install the meter. This cycle occurred 1-3 times per week for over a year.

Figure 2. Coriolis being removed from a pipeline.

The pipeline downtime resulted in a significant resource draw for Pembina operations with each occurrence. Each shut-in required two operators to drive 2 hours to the site, then spend 2-3 hours removing the meter, steaming the meter to clean it, and re-installing the meter. Additionally, for every occurrence another operator had to drive to the site to prove the meter after it was returned to service. The downtime also caused potential revenue losses for the producer when monthly nominations weren't achieved due to the outages.

Pembina decided to treat one of the Coriolis meters at the site to help reduce downtime and maintenance costs. To ensure accuracy wasn't compromised by applying e9 Treatments to the meter, a prover tested the meter before and after treatment the day it was put into service. The meter factor change was negligible.
